Manhole Inspection Summary

Manhole # S37E__002MH

Insp Date: **8/26/08 9:15 AM**

Location Address: **15 e fayette st**

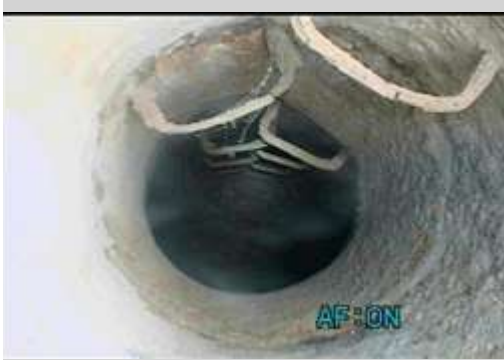
Defect 2

Steps Count: **9** Missing: **0** ☒ **Corroded**

steps

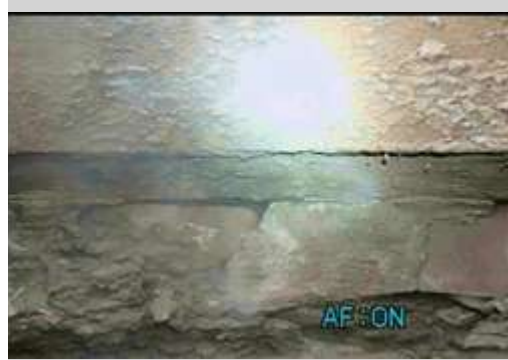
Defect 1

Condition: ☐ Sound ☒ **Cracked** ☐ Root Intrusion ☐ Loose Brick ☐ Deteriorated

Chimney cracked,
frame adj

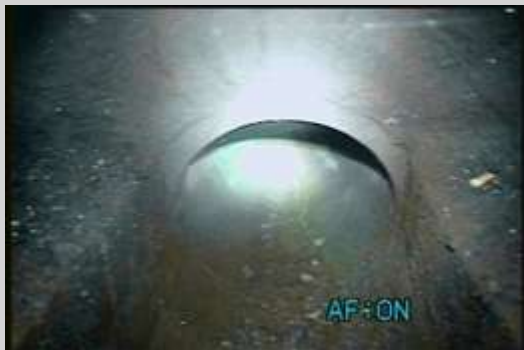
12 O'Clock Outflow

10 in. Circular Gravity Sewer
Pipe Out @ 12 O'Clock

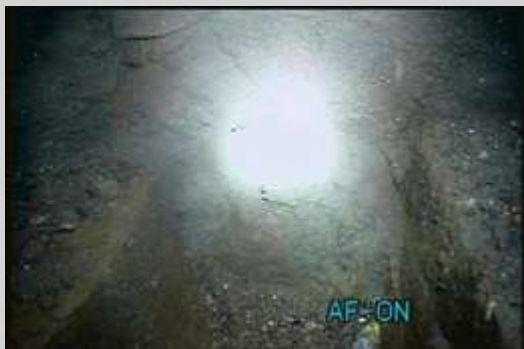
5 O'Clock Inflow

Comments **Pipe at 5 is sealed**

10 in. Circular Gravity Sewer
Pipe In @ 5 O'Clock

Deposits: ☐ None ☐ Mud ☐ Sludge ☒ **Debris** ☐ Grease

Silt Depth: 7 (in.) Deposits Extent: **Heavy**
